LAWRENCE
LIVERMORE
NATIONAL
LABORATORY

LLNL-TR-648143

A Visual Description of the Concrete Exterior of the Cactus Crater Containment Structure

October 2013

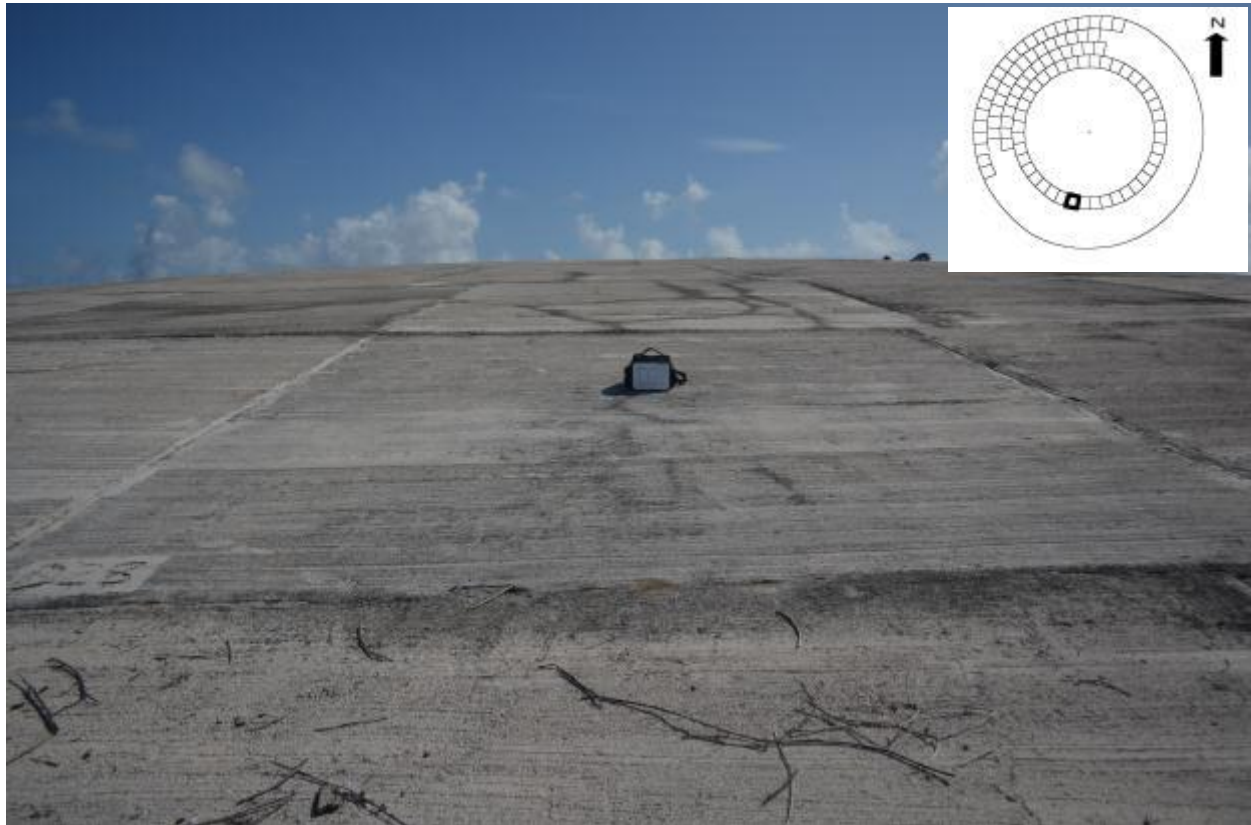
CAP SECTION LOCATION: Panel D29

The upper portion of the panel has a rough and weathered appearance. A minor surface crack observed traversing across the upper portion of the panel.

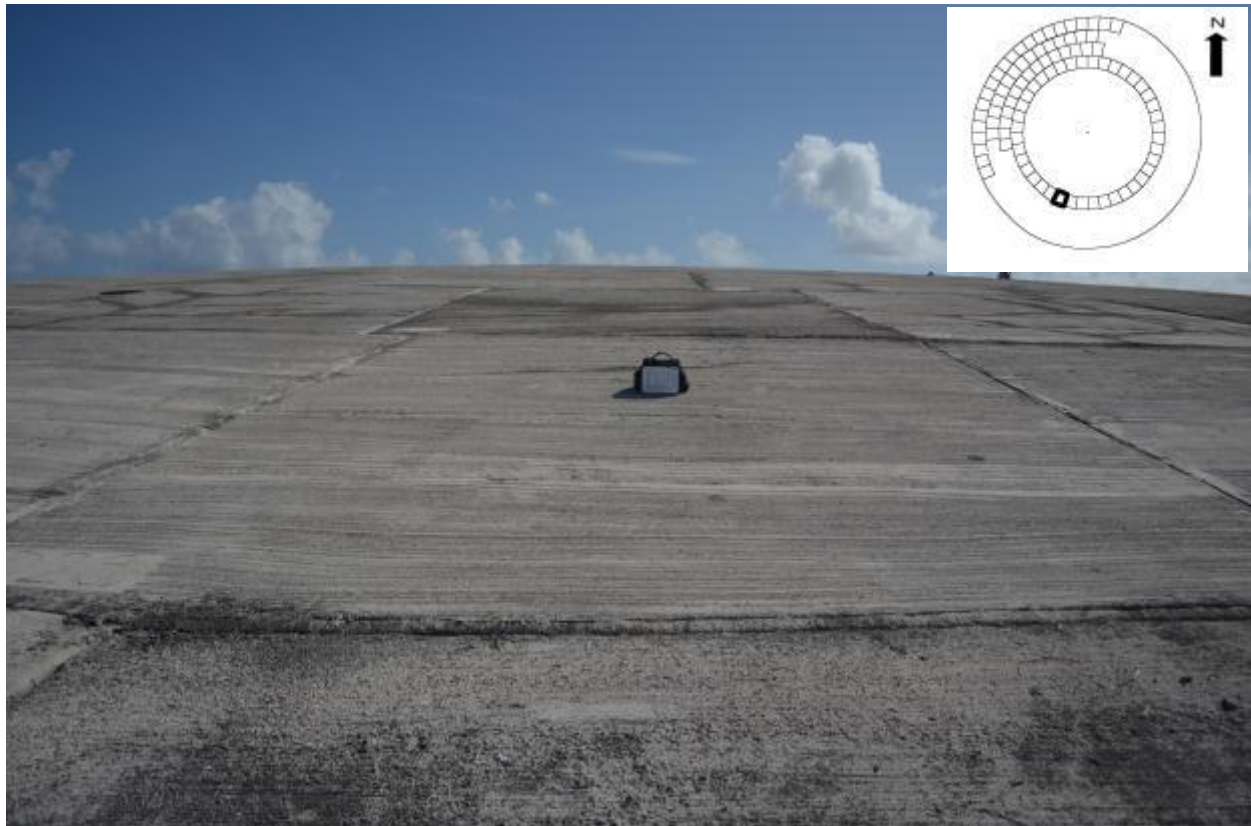
CAP SECTION LOCATION: Panel D30

No significant or obvious interior cracks extending across the top of the panel. The panel has a rough and weathered appearance. Some spalling/cracking of concrete observed in the upper left-hand corner of the panel. Rooting vegetation removed from along the panel seams.

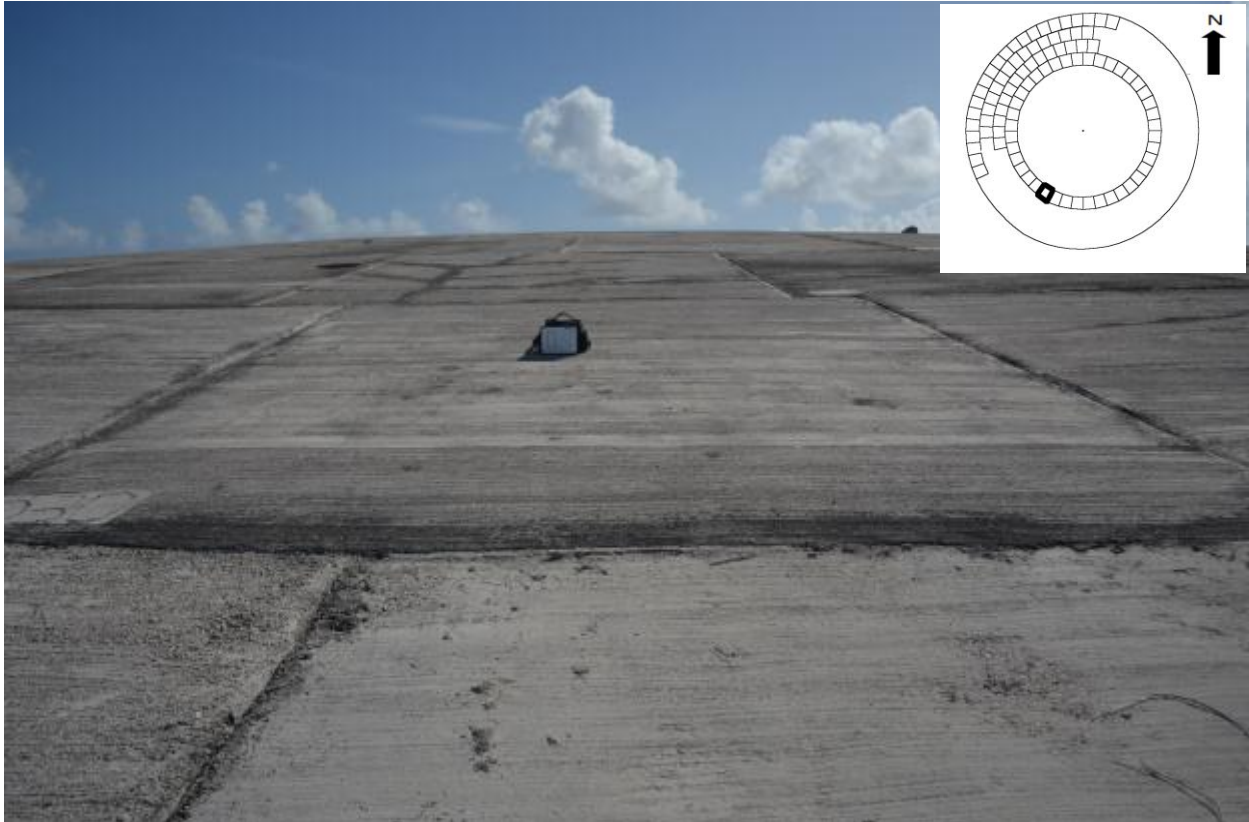
CAP SECTION LOCATION: Panel D31

The panel has a rough and weathered appearance. Rooting vegetation removed from along the panel seams. A surface crack observed traversing across the left corner of the panel intersecting the bottom and left seams about 2.5 to 3 meters away from the corner of the panel.

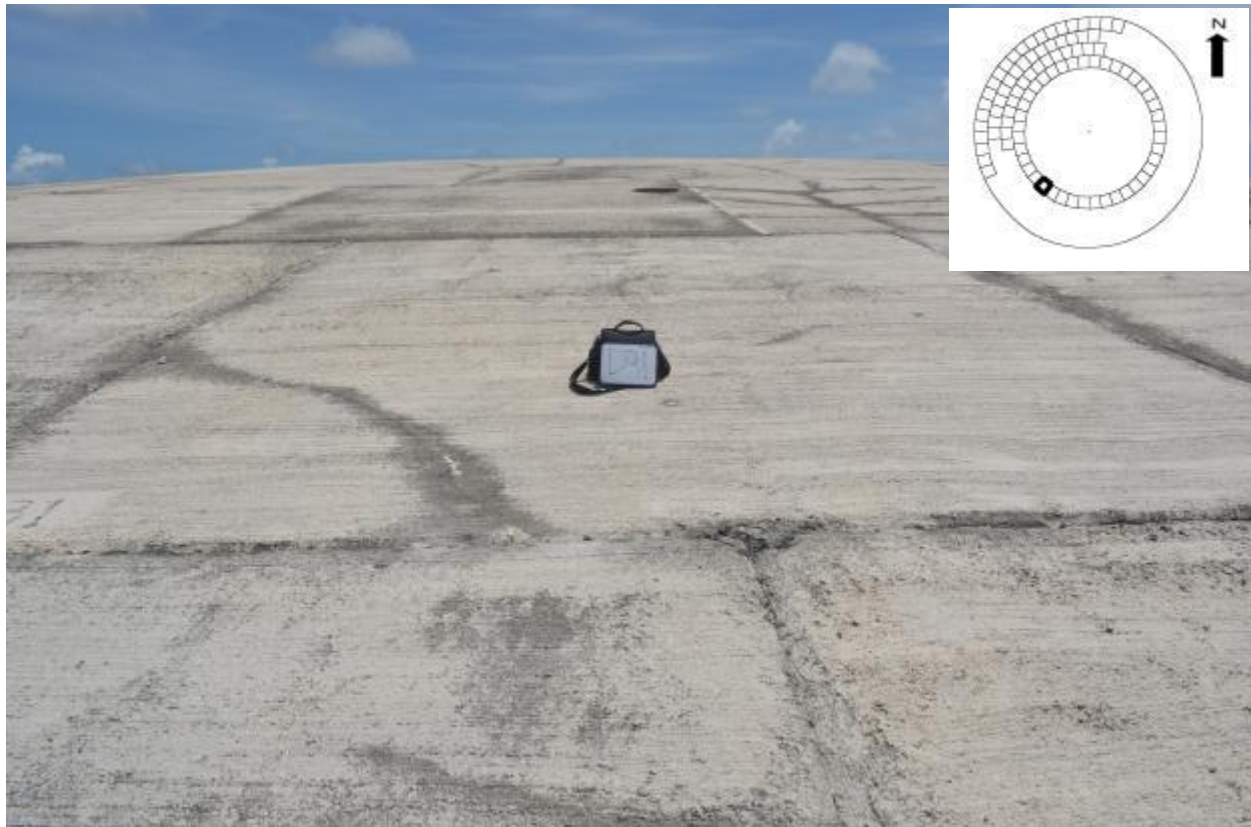
CAP SECTION LOCATION: Panel D32

No significant or obvious interior cracks extending across the top of the panel. The panel has a rough and weathered appearance. Rooting vegetation removed from along the panel seams.

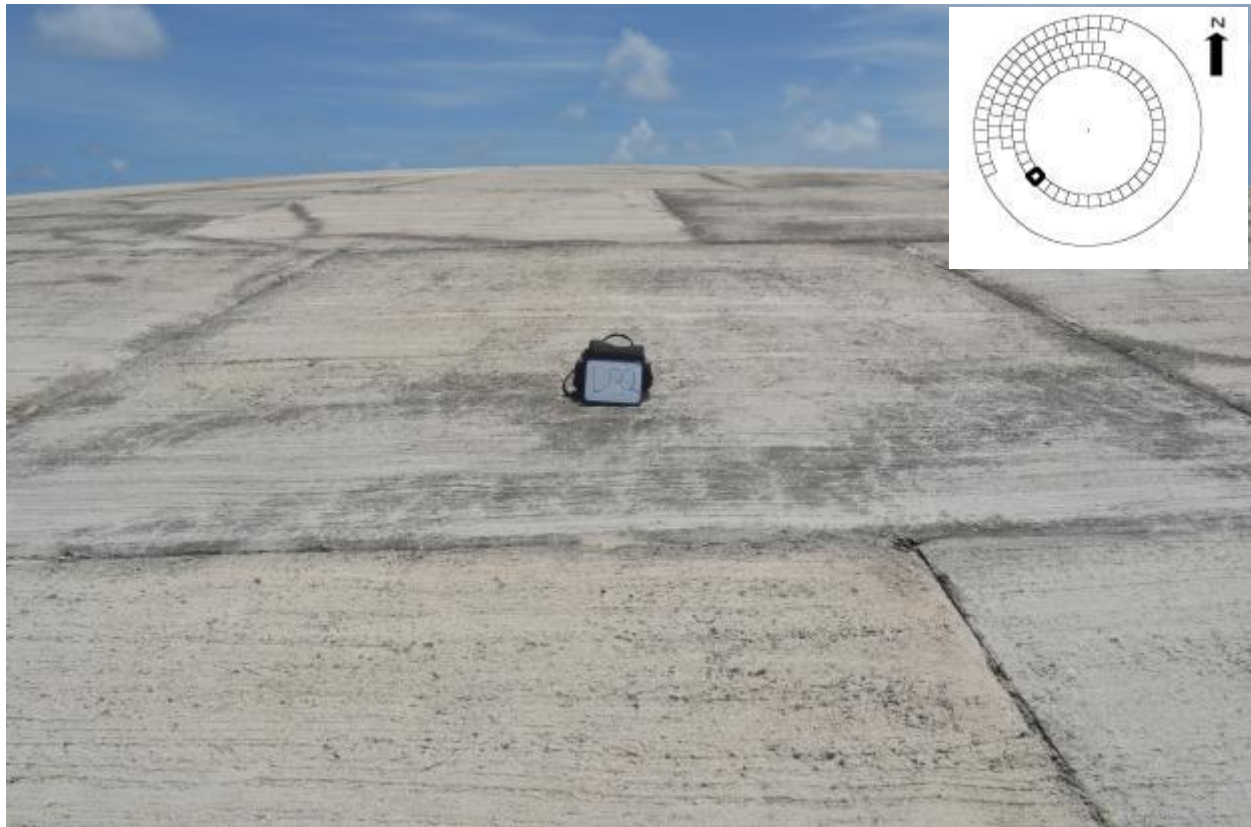
CAP SECTION LOCATION: Panel D33

No significant or obvious interior cracks extending across the top of the panel. The panel has a rough and weathered appearance.

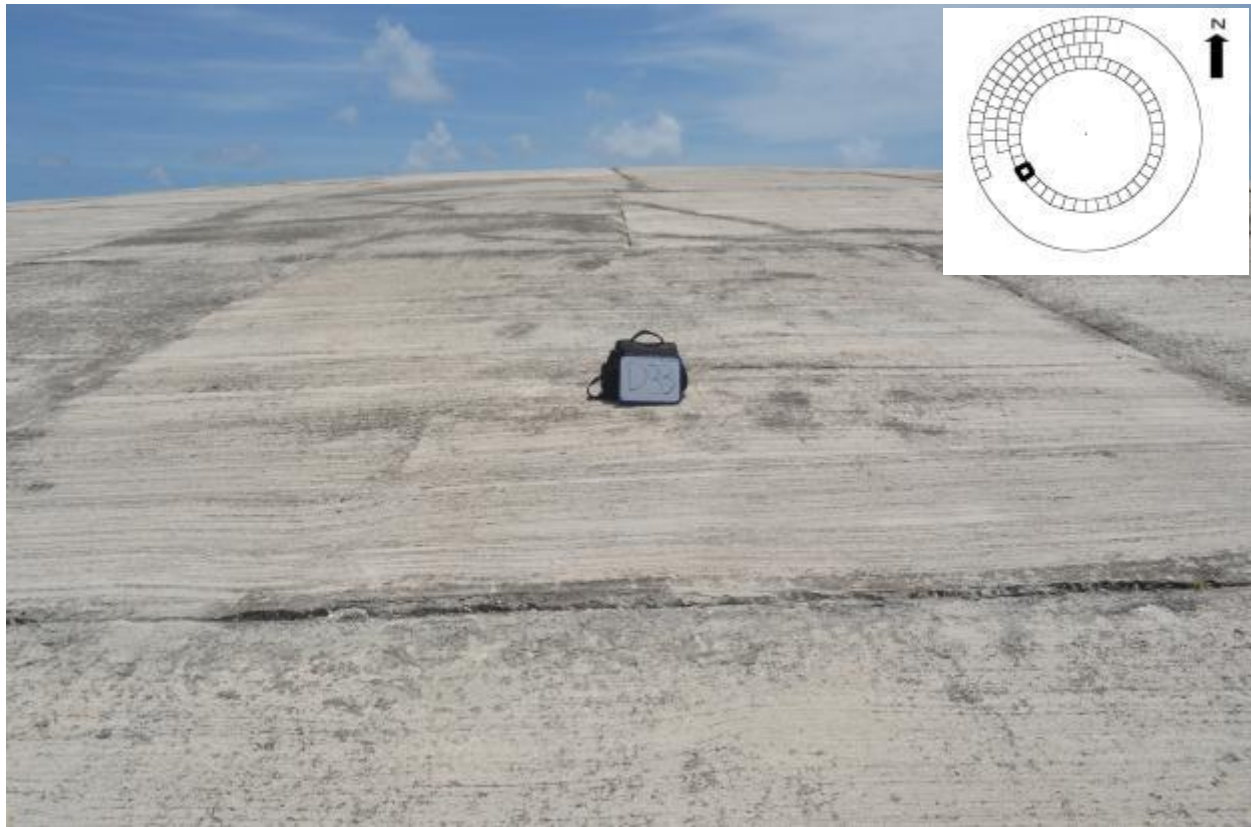
CAP SECTION LOCATION: Panel D34

No significant or obvious interior cracks extending across the top of the panel. The panel has a rough and weathered appearance. Some spalling/cracking of concrete observed in the upper left-hand corner of the panel. Rooting vegetation removed from along the panel seams.

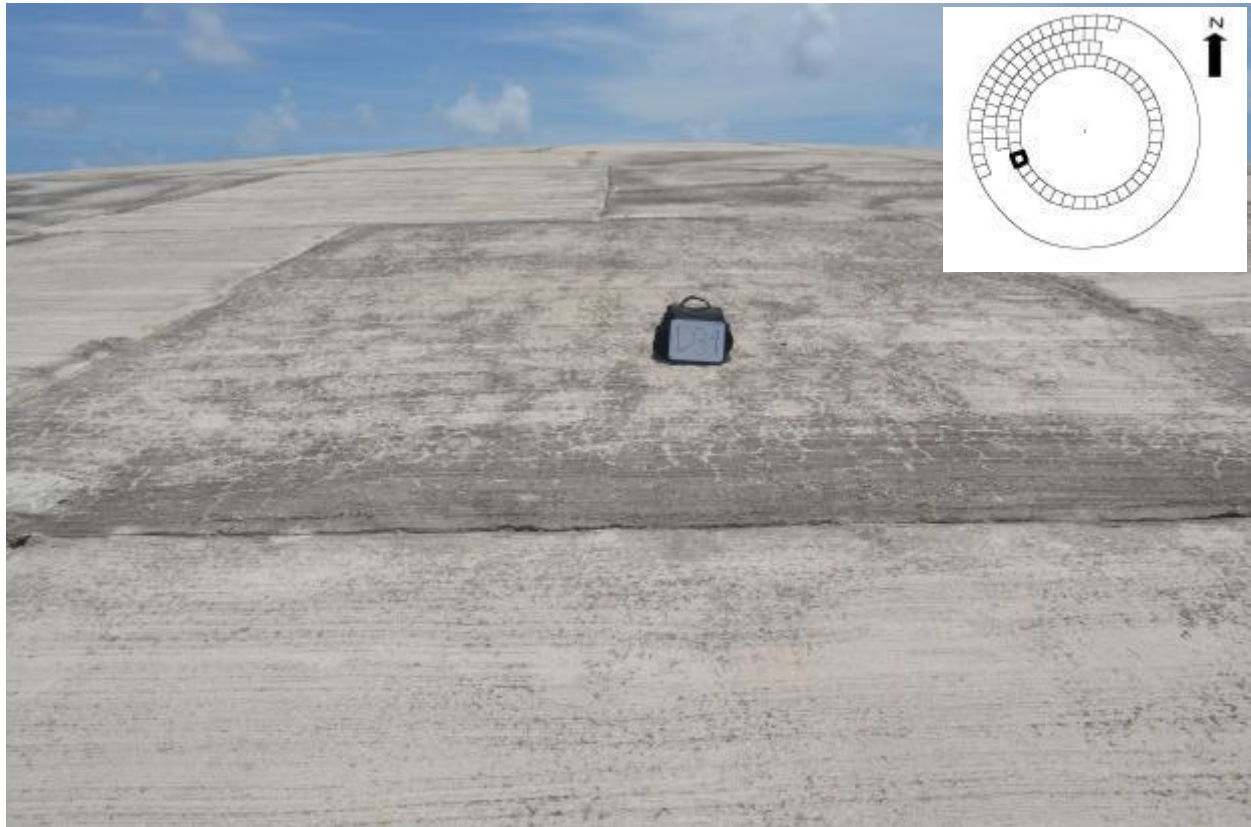
CAP SECTION LOCATION: Panel D35

Some spalling/cracking of concrete observed in the lower left-hand corner of the panel. Rooting vegetation removed from along the panel seams. A surface crack observed extending up from a central position along the bottom seam intersecting the upper seam adjacent corner E28/E29 on the ring row above with a branch off to the left side at a mid-point up the panel.

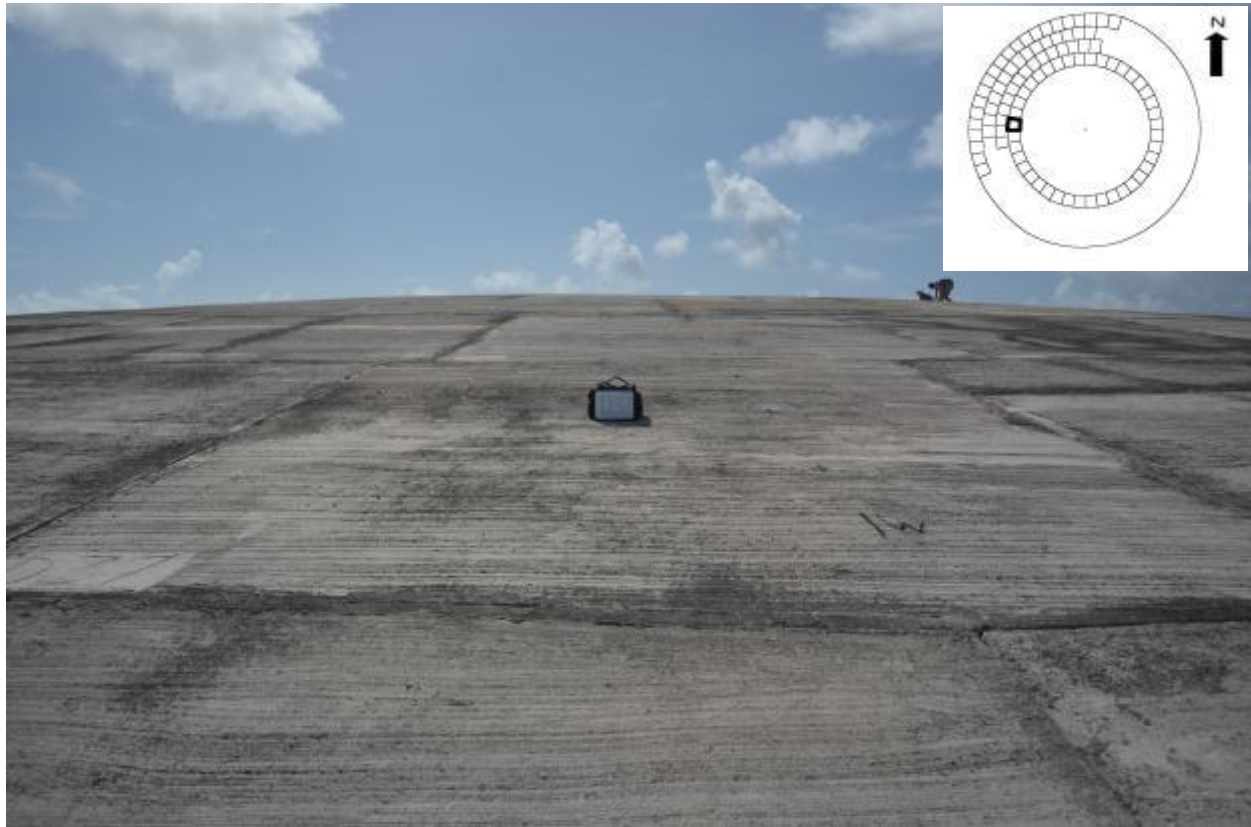
CAP SECTION LOCATION: Panel D38

No significant or obvious interior cracks extending across the top of the panel. The panel has a slightly more rough and weathered appearance. Some spalling/cracking of concrete observed in the upper left-hand corner and along the right side of the upper seam of the panel. Rooting vegetation removed from along the panel seams.

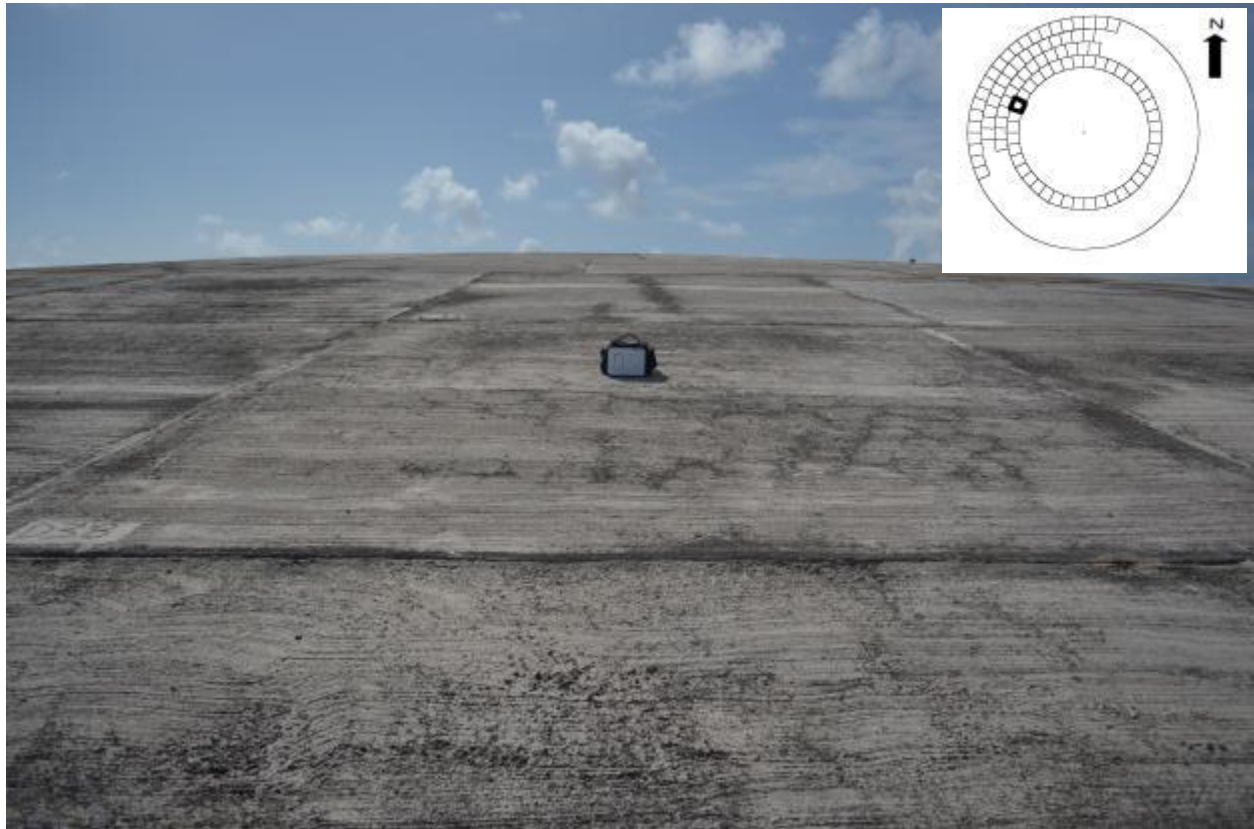
CAP SECTION LOCATION: Panel D39

No significant or obvious interior cracks extending across the top of the panel. The panel has a rough and weathered appearance. Some spalling/cracking of concrete observed in the upper and lower left corners.

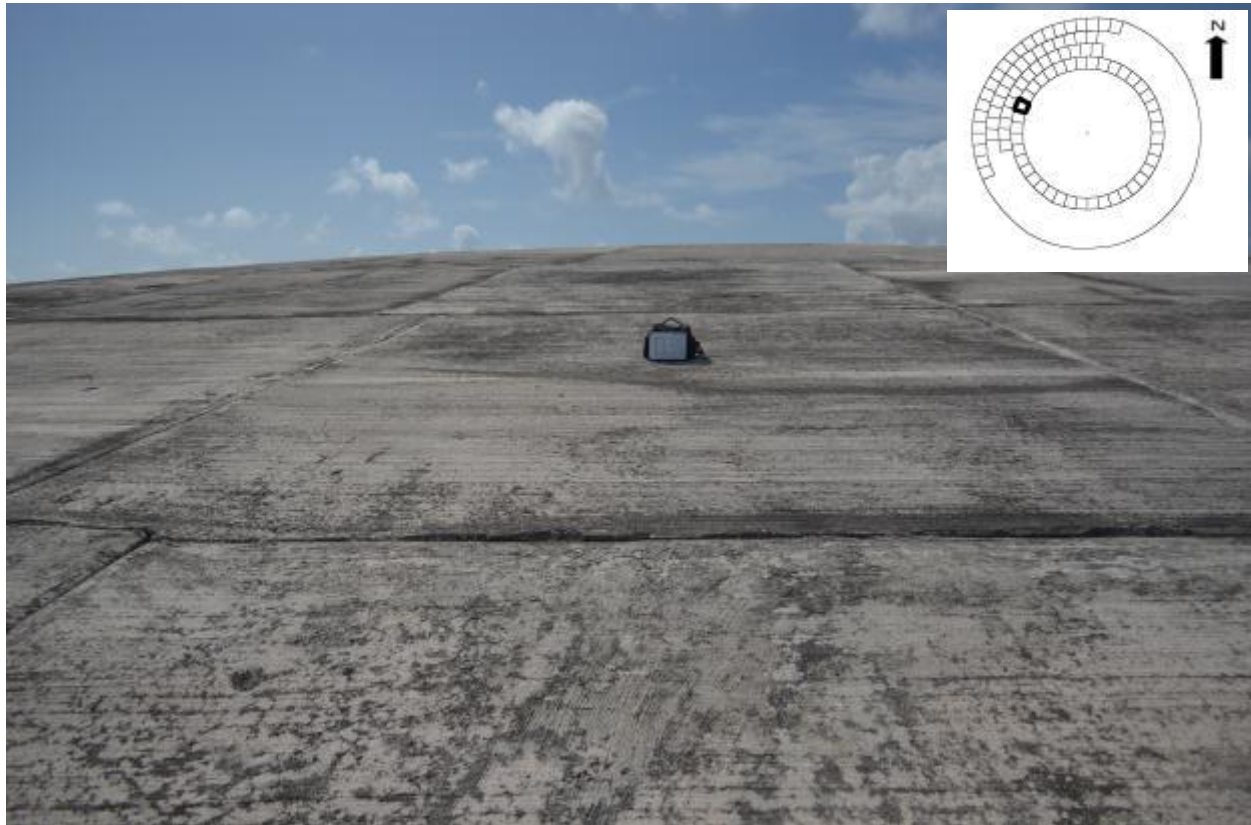
CAP SECTION LOCATION: Panel D40

No significant or obvious interior cracks extending across the top of the panel. The panel has a slightly more rough and weathered appearance. Rooting vegetation removed from along the panel seams.

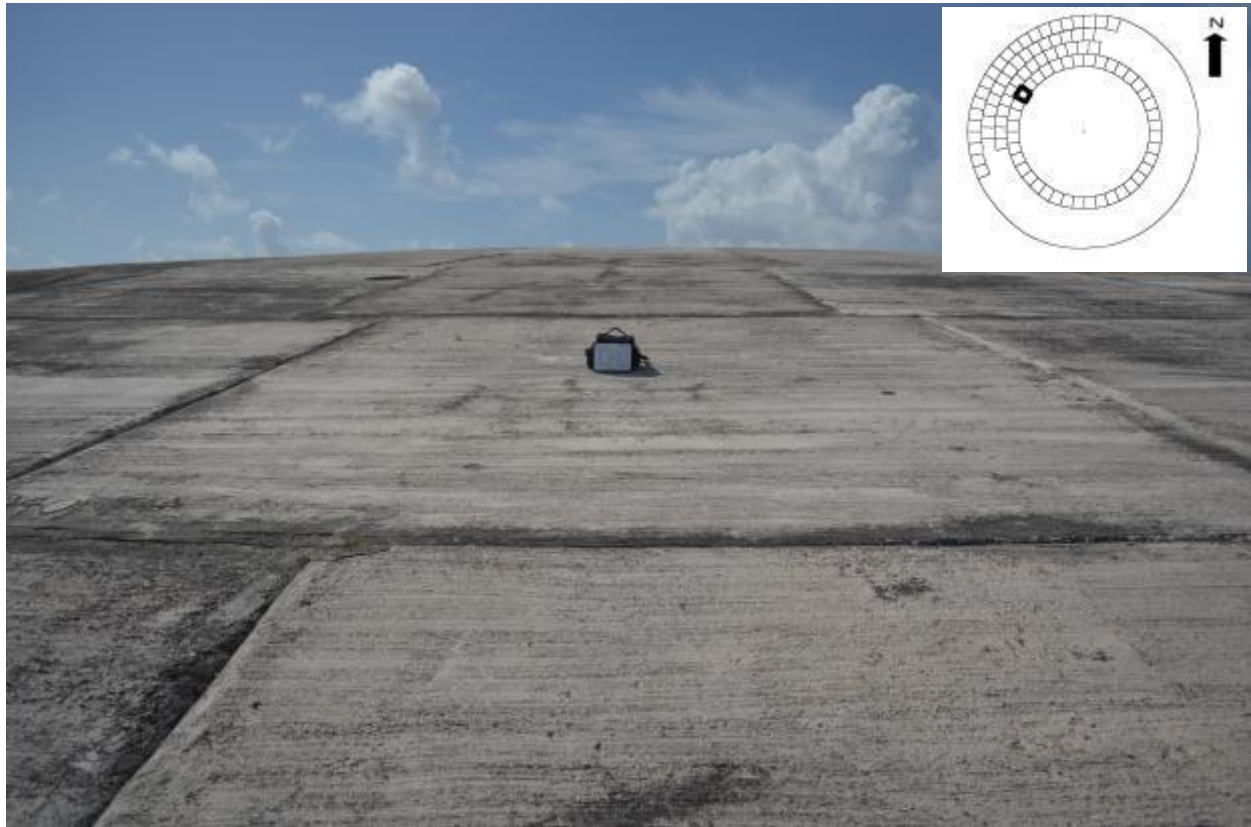
CAP SECTION LOCATION: Panel D41

This panel has a rough and weathered appearance. Some spalling/cracking of concrete observed in the lower left-hand corner and along the left seam of the panel. A significant crack observed extending up through the middle of the panel from a central position along the bottom seam adjacent to the intersecting corner of panels on the ring row below. The crack has chipped “spalled” edges. The panel is recommended for priority repair.

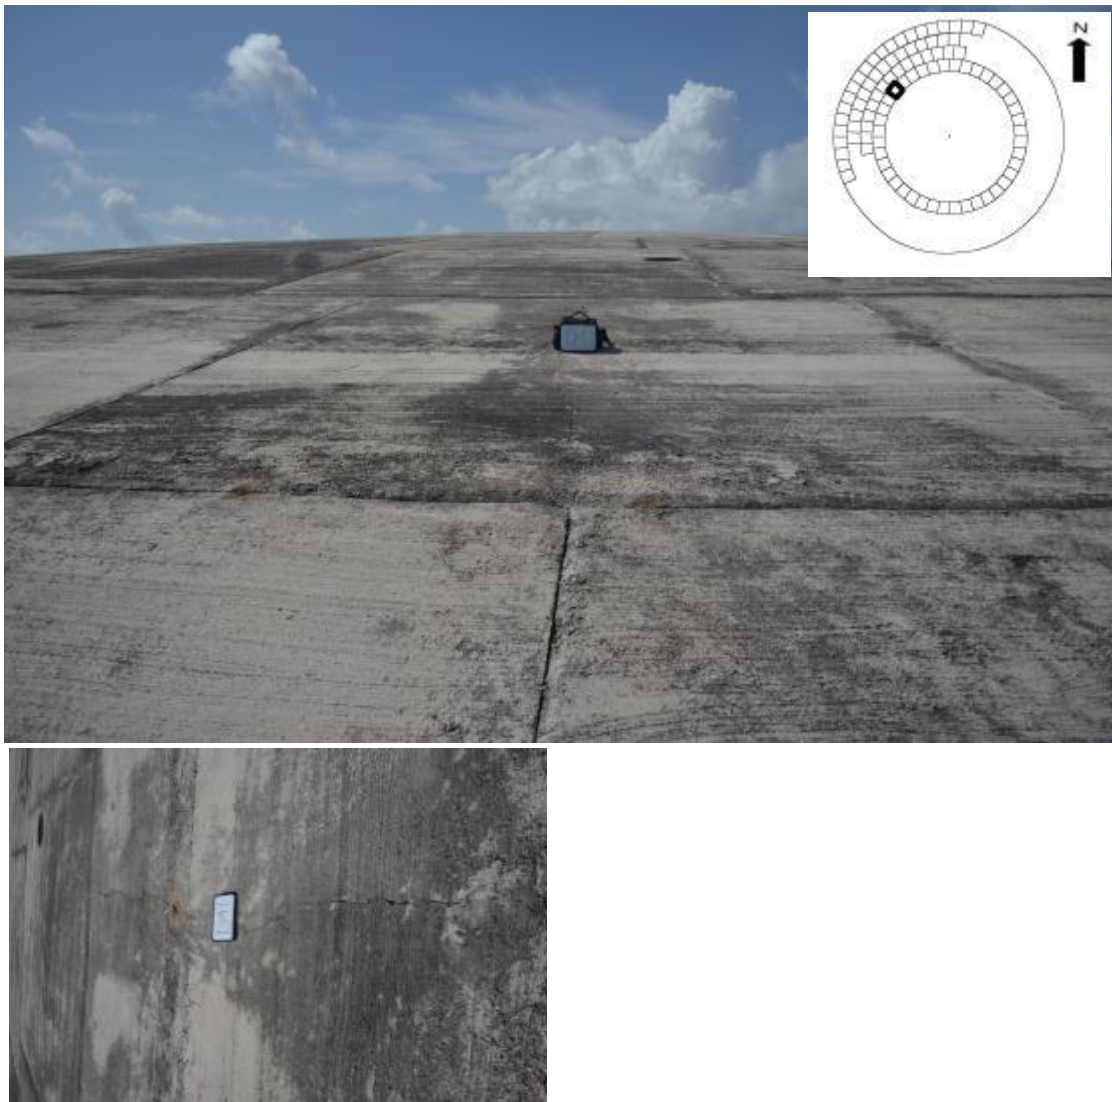
CAP SECTION LOCATION: Panel D42

No significant or obvious interior cracks extending across the top of the panel. Some minor spalling/cracking of concrete observed near the left corner of bottom beam

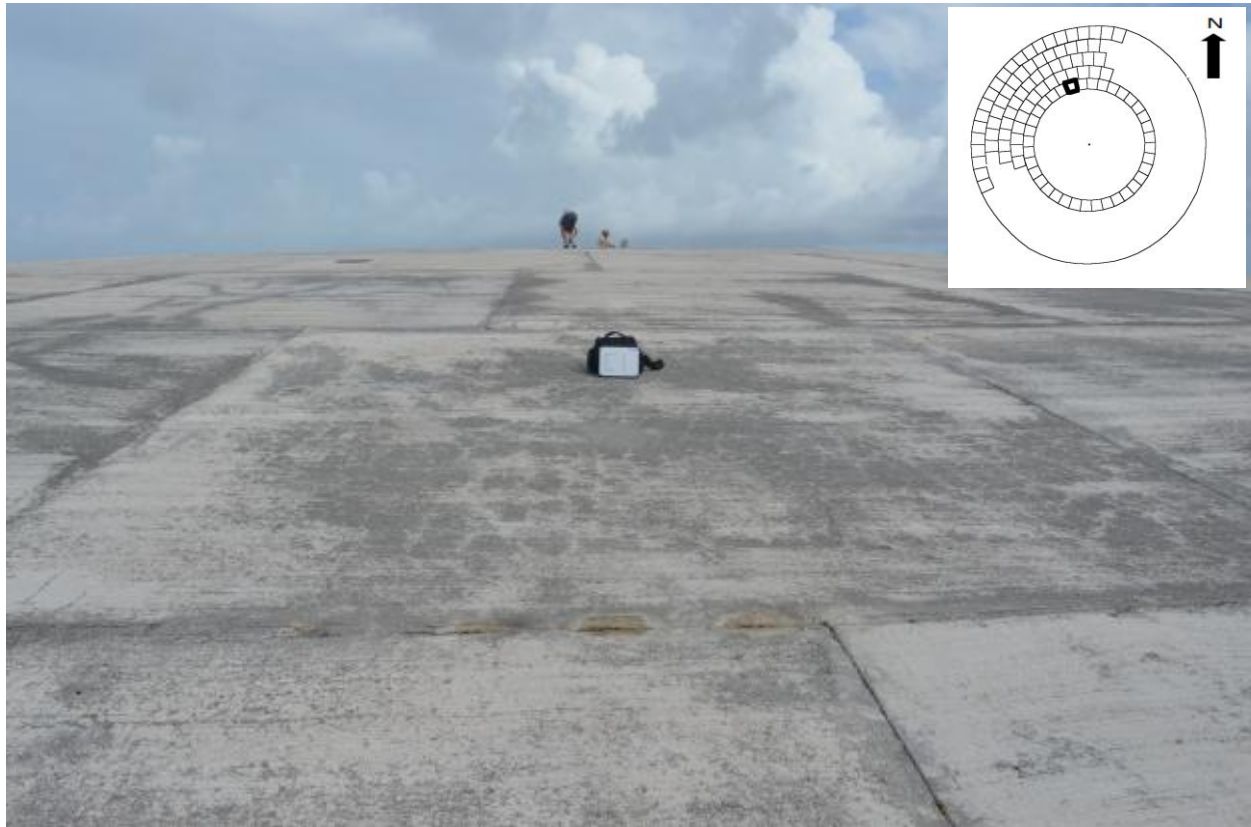
CAP SECTION LOCATION: Panel E1

No significant or obvious interior cracks extending across the top of the panel. Some minor spalling/cracking of concrete observed in the upper left-hand corner of the panel. Rooting vegetation removed from along the panel seams.

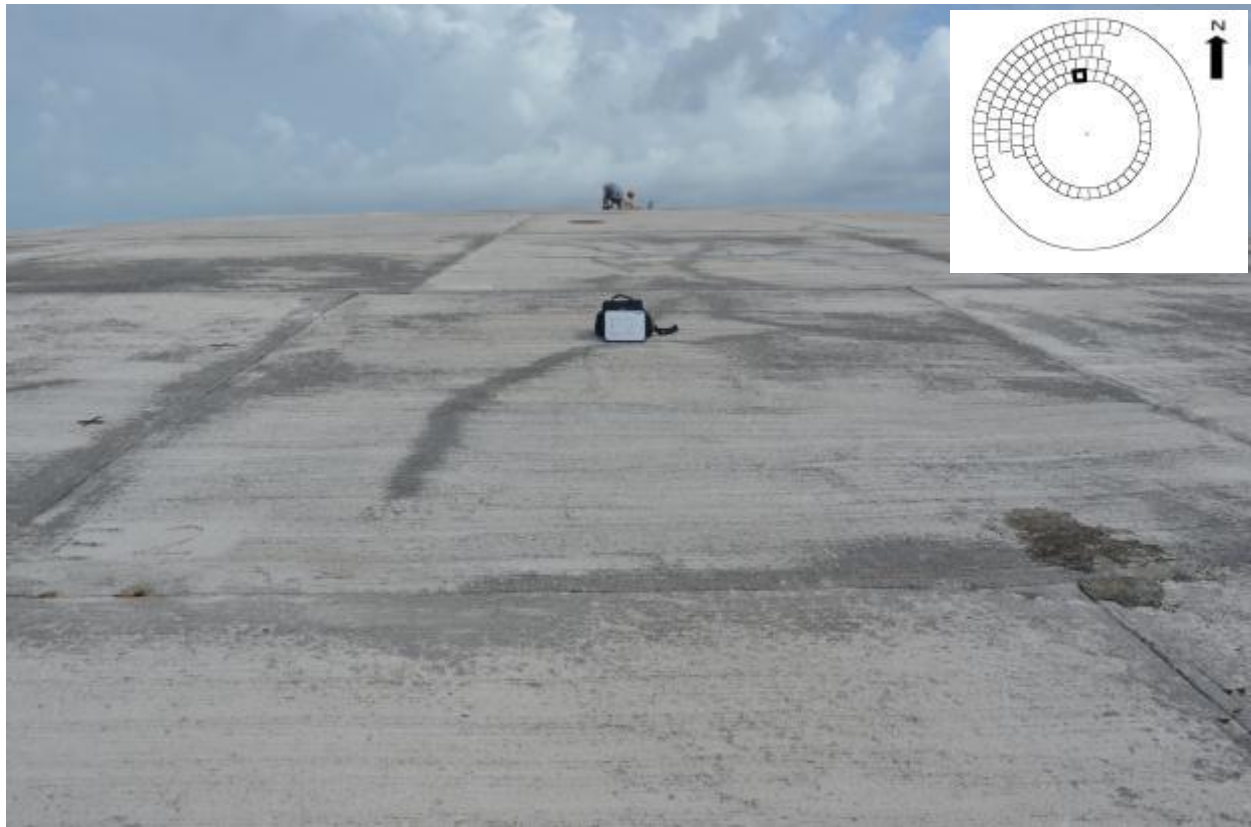
CAP SECTION LOCATION: Panel E2

No significant or obvious interior cracks extending across the top of the panel. Some minor spalling/cracking of concrete observed along the lower side of the right seam. Rooting vegetation removed from along the panel seams.

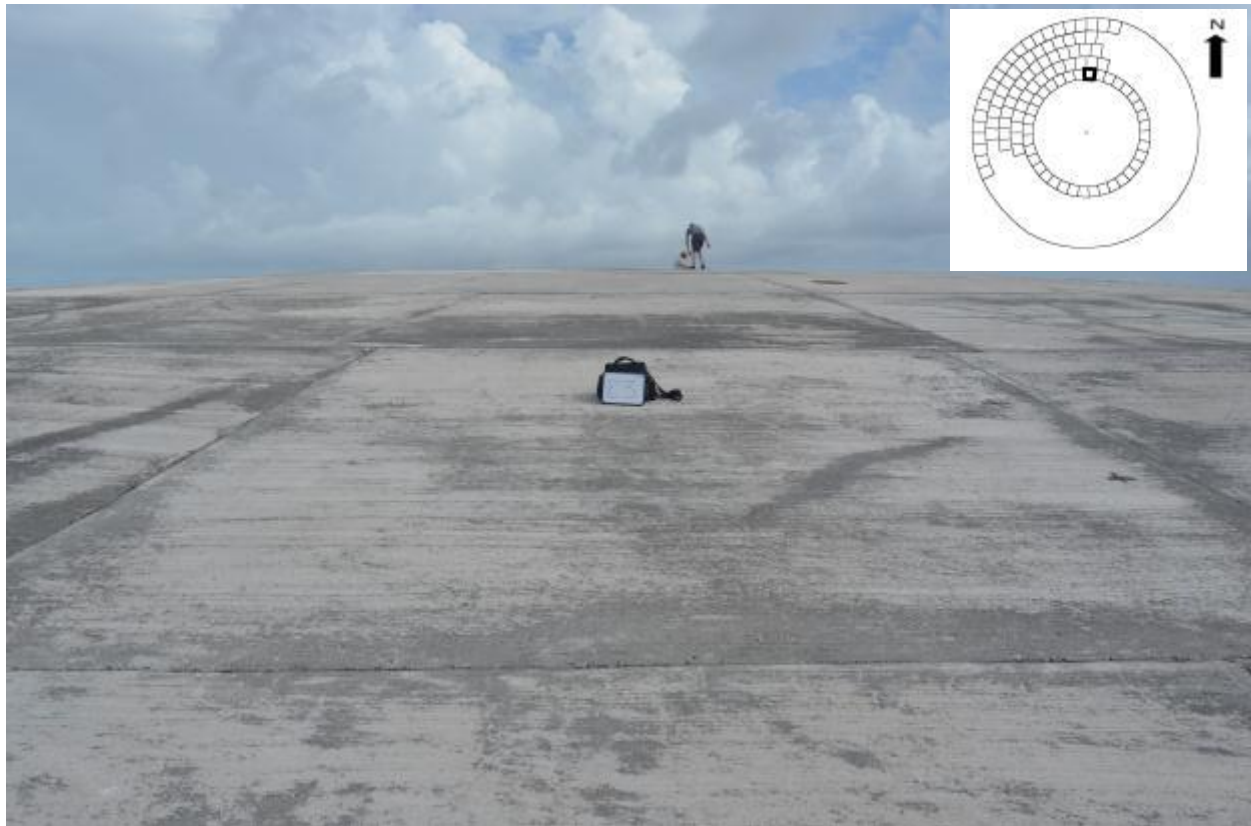
CAP SECTION LOCATION: Panel E3

No significant or obvious interior cracks extending across the top of the panel. Some minor spalling/cracking of concrete observed near the upper right-hand corner of the panel.

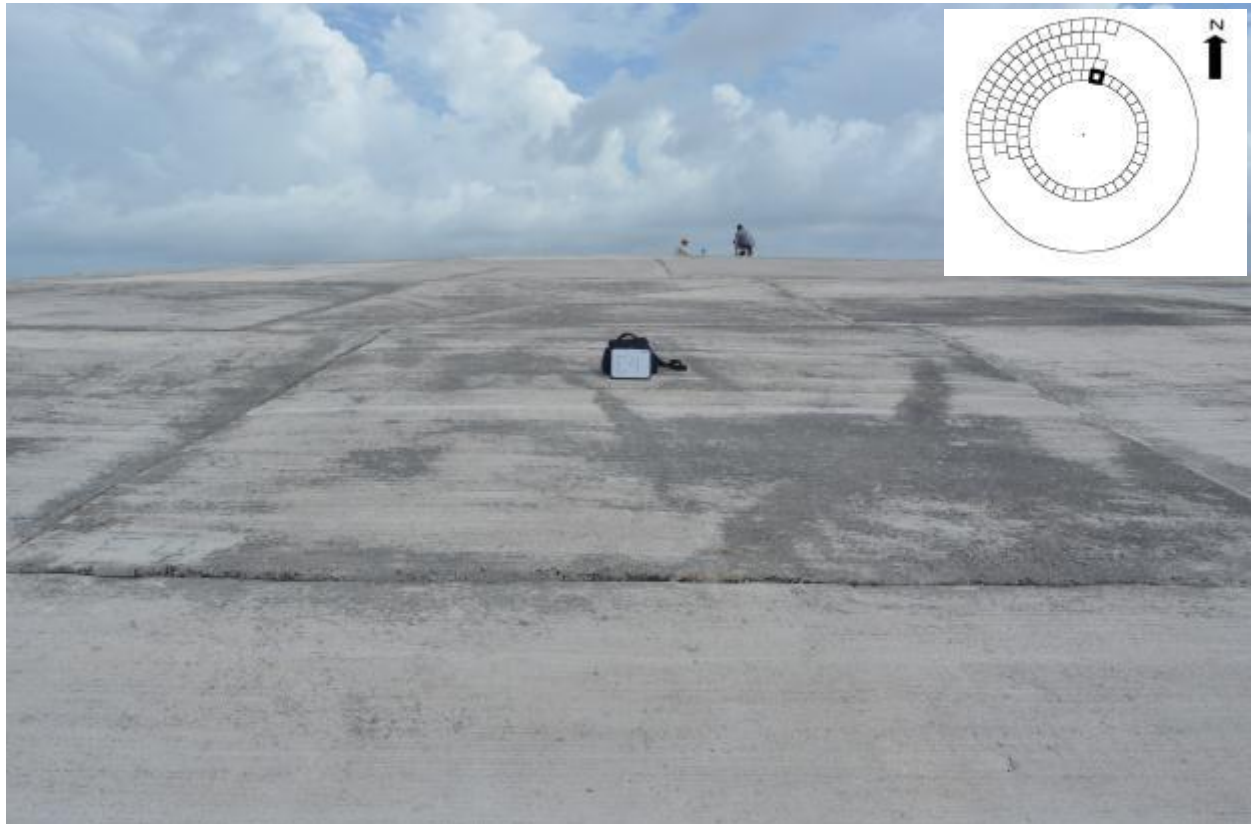
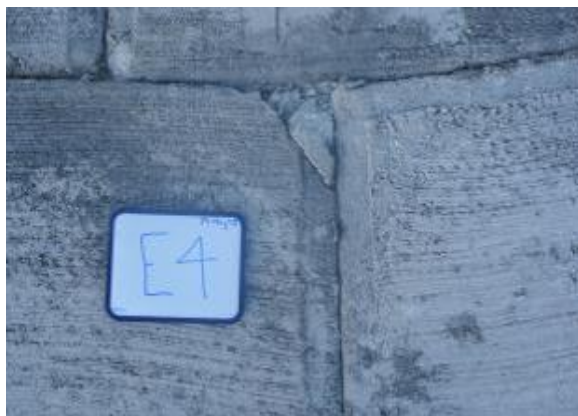
CAP SECTION LOCATION: Panel E4

No significant or obvious interior cracks extending across the top of the panel. The bottom right side of the panel has a rough and weathered appearance. Some spalling/cracking of concrete observed in the upper left and right-hand corners of the panel.

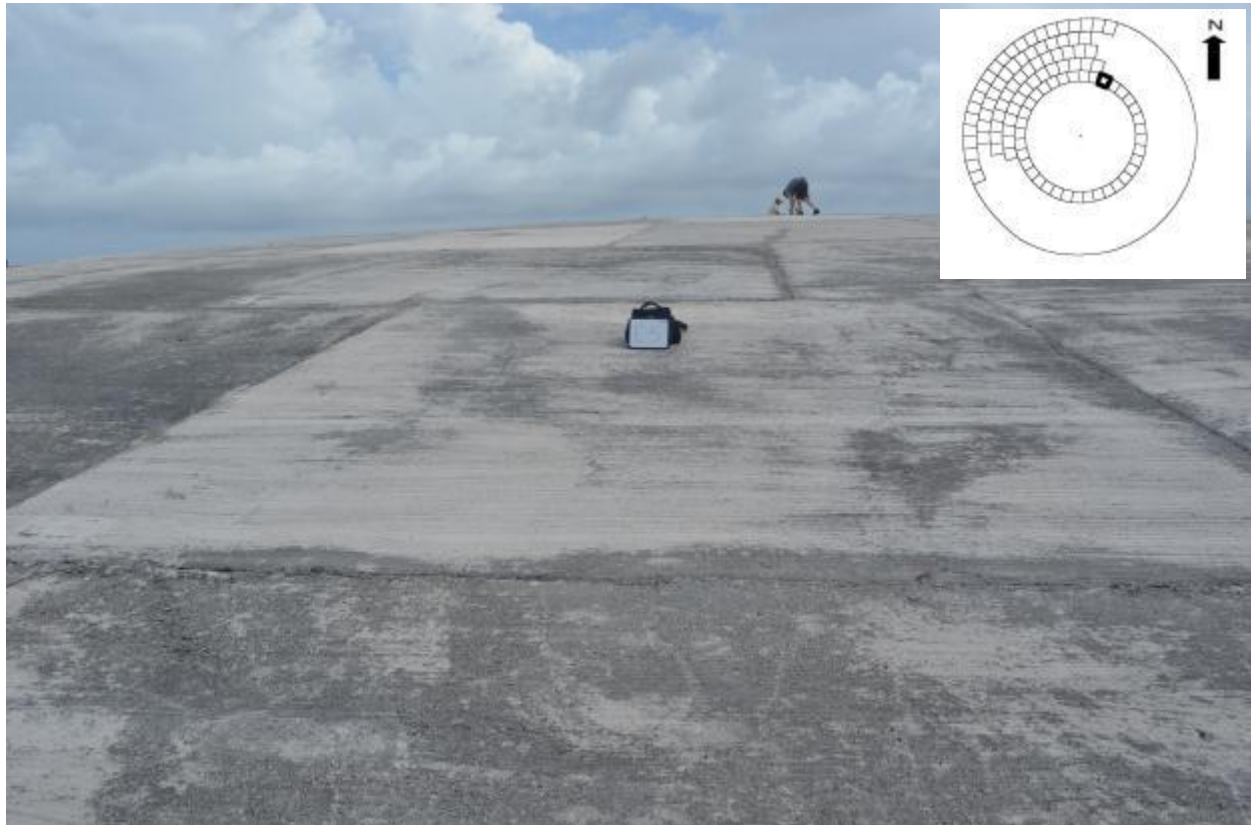
CAP SECTION LOCATION: Panel E5

No significant or obvious interior cracks extending across the top of the panel. Some minor spalling/cracking of concrete observed in the lower right corner of the panel. Rooting vegetation removed from along the panel seams.

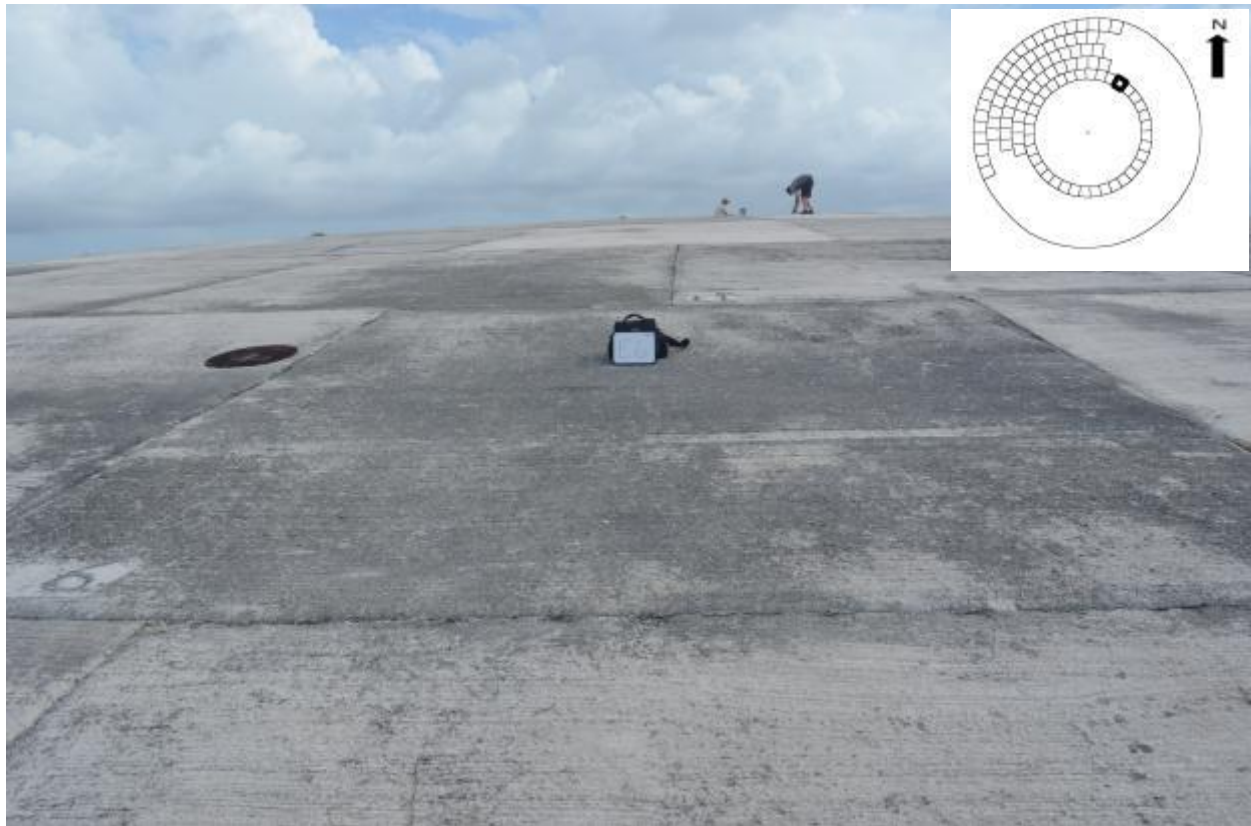
CAP SECTION LOCATION: Panel E6

No significant or obvious interior cracks extending across the top of the panel. Panel has a rough and weathered appearance.

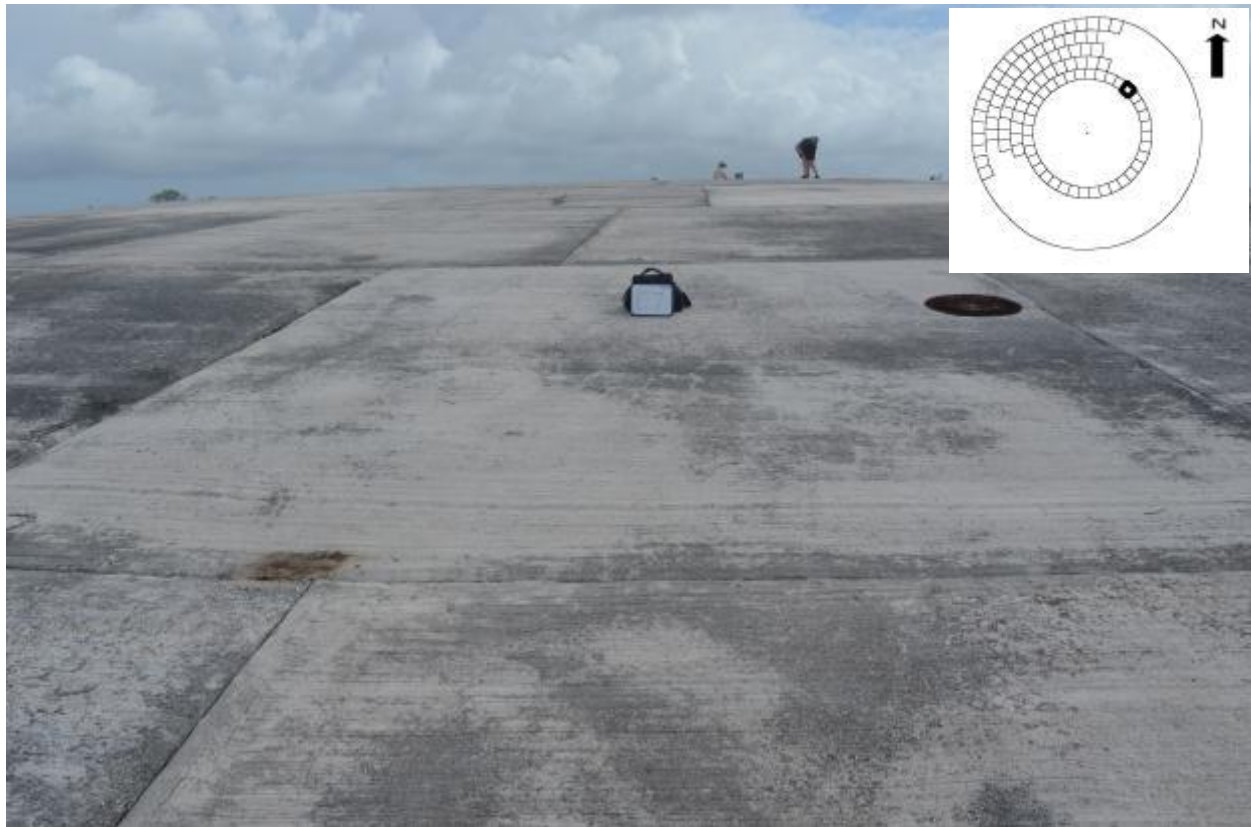
CAP SECTION LOCATION: Panel E7

No significant or obvious interior cracks extending across the top of the panel. Rooting vegetation (mainly grasses) removed from along the panel seams. Panel contains a vertical elevation benchmark.

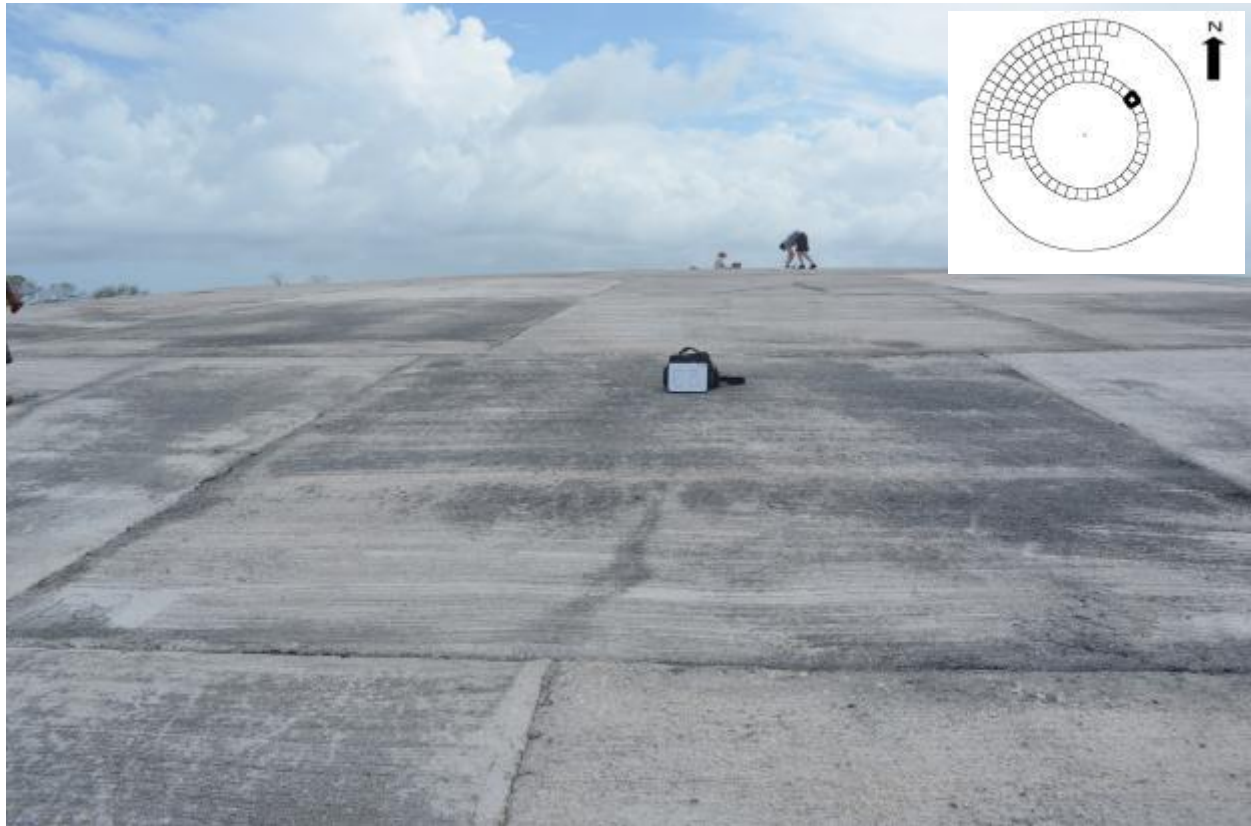
CAP SECTION LOCATION: Panel E8

No significant or obvious interior cracks extending across the top of the panel. Panel has a rough and weathered appearance. Some spalling/cracking of concrete observed in the upper left-hand corner of the panel and along the lower left seam
